Manhole Inspection Summary

Manhole # S39CC1022MH

Location Address: **807 MELVILLE AVE**

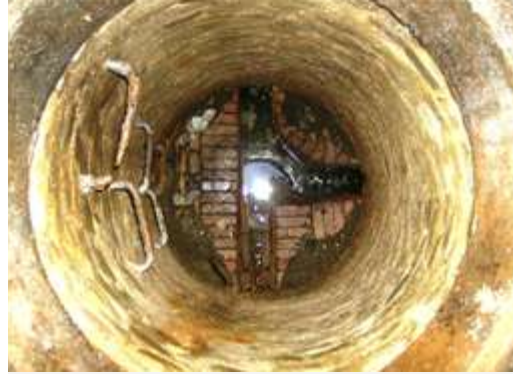
Top View

Corroded steps. Evidence of surcharge - Bench debris. Channel debris.

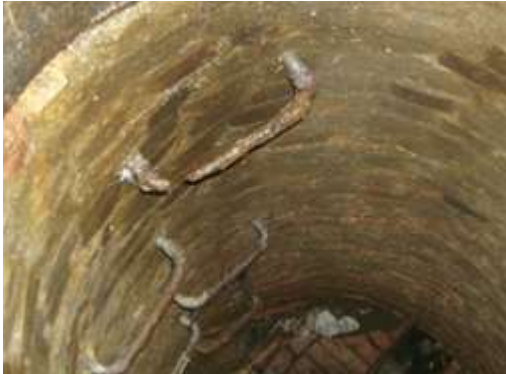
Defect

Frame leaks. Adjustment and Barrel infiltration.

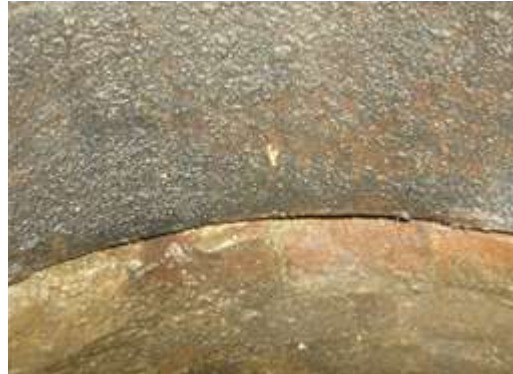
Defect

Frame leaks. Adjustment infiltration.

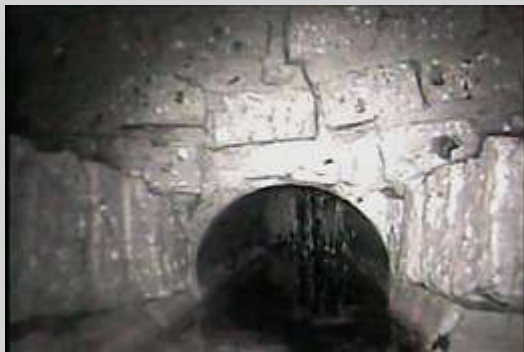
8 in. Circular Gravity Sewer Pipe Out @ 12 O'Clock

Channel deterioration.

Deposits: ☐ None ☒ **Mud** ☐ Sludge ☒ **Debris** ☐ Grease

Infiltration: **None** Pipe Seal Cond: **Cracked**

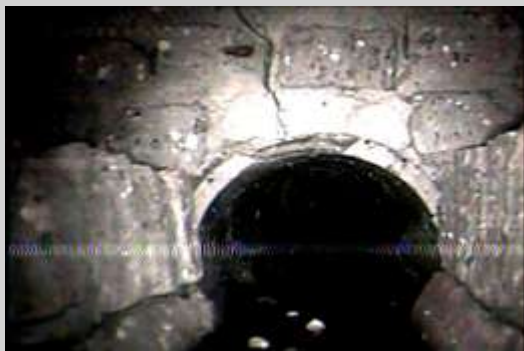
8 in. Circular Gravity Sewer Pipe In @ 3 O'Clock

Deposits: ☐ None ☒ **Mud** ☐ Sludge ☒ **Debris** ☐ Grease

Infiltration: **Evidence** Pipe Seal Cond: **Broken**

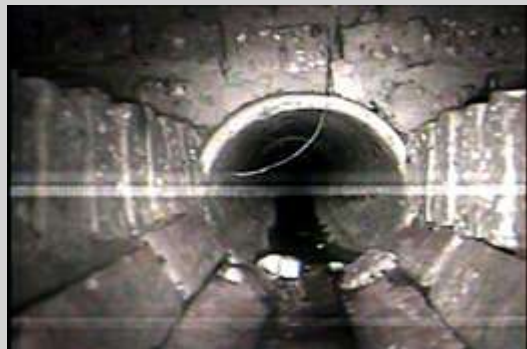
Pipe In @ 6 O'Clock

Deposits: ☐ None ☐ Mud ☐ Sludge ☒ **Debris** ☐ Grease
